Bureau of Mines Report of Investigations/1983

Kettlebottoms: Their Relation to Mine Roof and Support

By Frank E. Chase and Gary P. Sames

Report of Investigations 8785

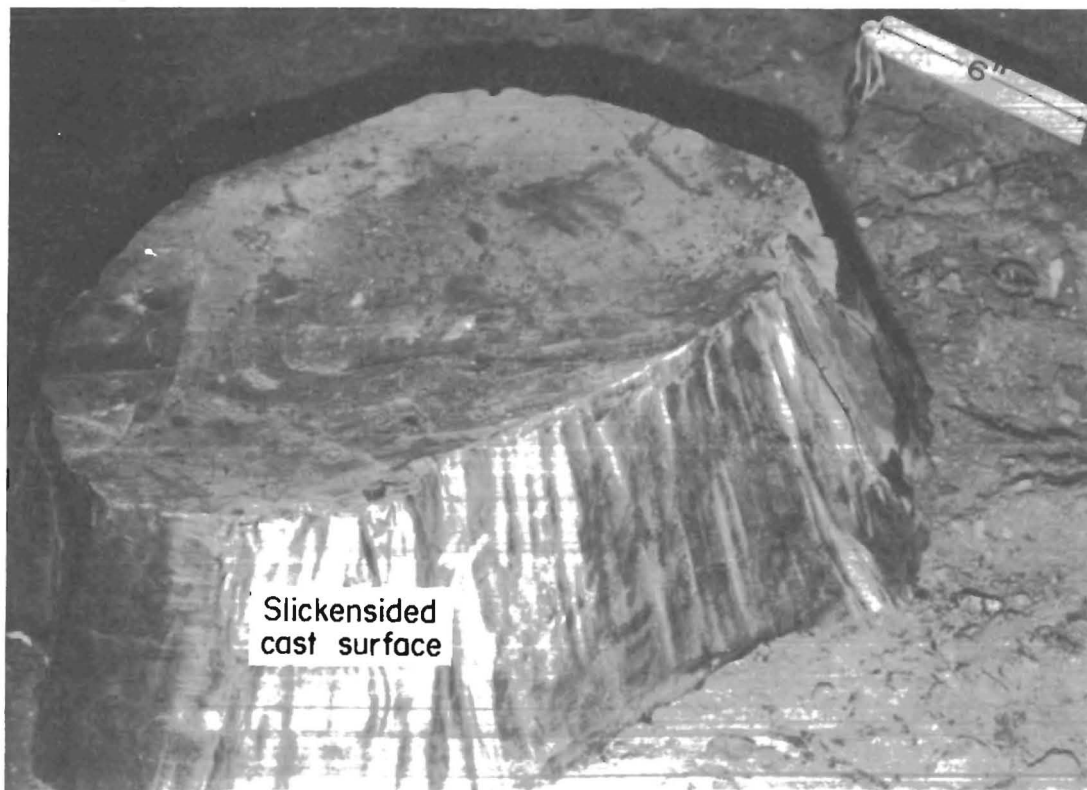
FIGURE 9. - Kettlebottom cast illustrating slickensided surface.

Kettlebottom mold and cast surfaces are highly slickensided (figs. 8 and 9). A characteristic layer of coalified bark remnants, a coal ring, which varies from a film to 3/4 in thick, usually separates the kettlebottom mold from its cast. Cohesion between the mold and cast is weak; after mining, only the tensile strength along bedding planes prevents kettlebottoms from detaching.

When the cast material is homogeneous and well cemented, the cast will detach as a single plug (fig. 9); this is how kettlebottoms most commonly detach. Poorly cemented casts tend to detach in platy slabs (fig. 12). Some kettlebottoms were found to be more resistant to weathering by humid mine air than adjacent roof strata (fig. 13).
